**Milestone Phase I Report
Ocean East Resort Club Association, Inc.**

Report Date: 9/24/2024

Inspection Date: 8/8/2024

867 S Atlantic Ave, Ormond Beach, FL 32176, USA

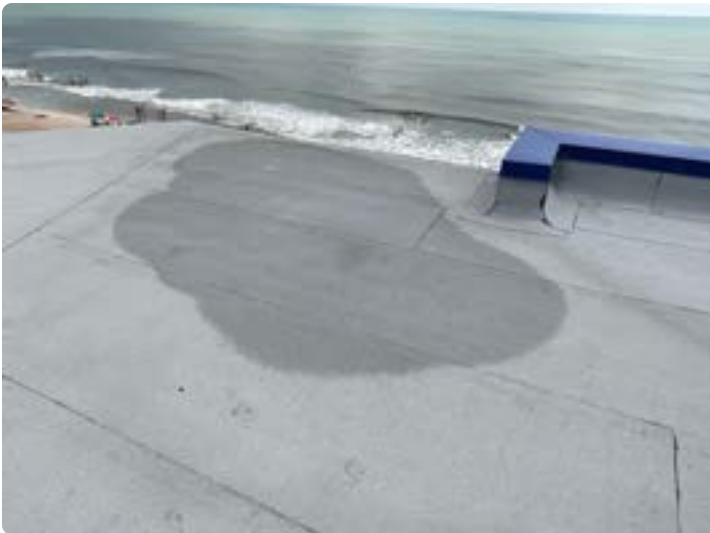
Small area of water ponding on roof

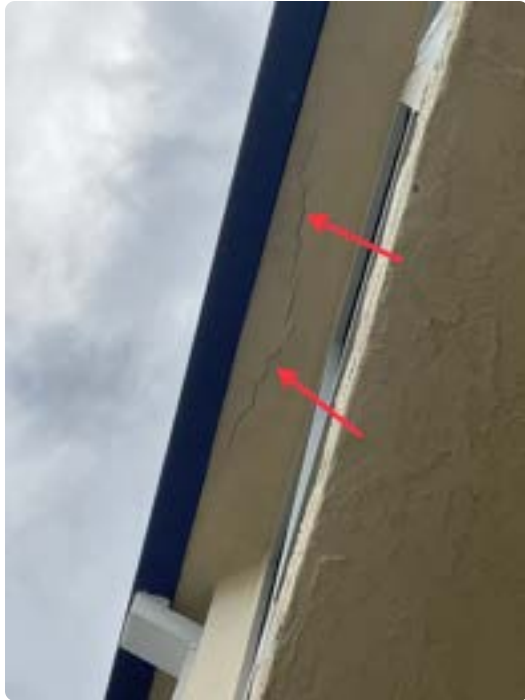
Concrete spalling on top floor soffit above Unit 4004

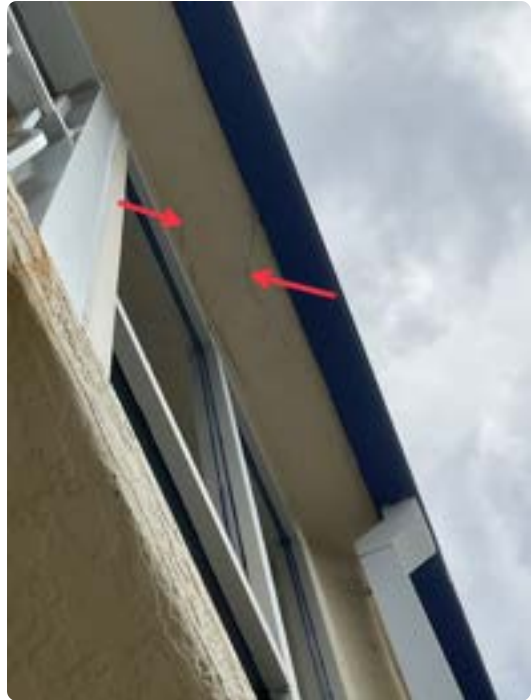
Concrete spalling in roof soffit above Unit 4005

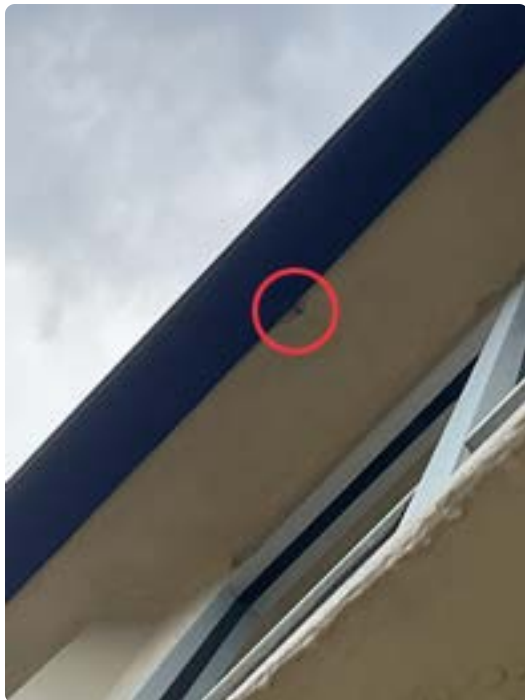
Small area of concrete spalling on roof soffit above Unit 4014

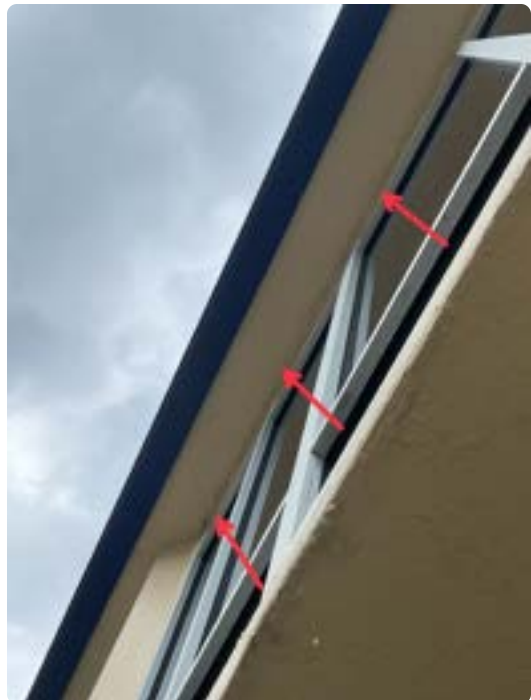
Concrete spalling in roof soffit above Unit 4022

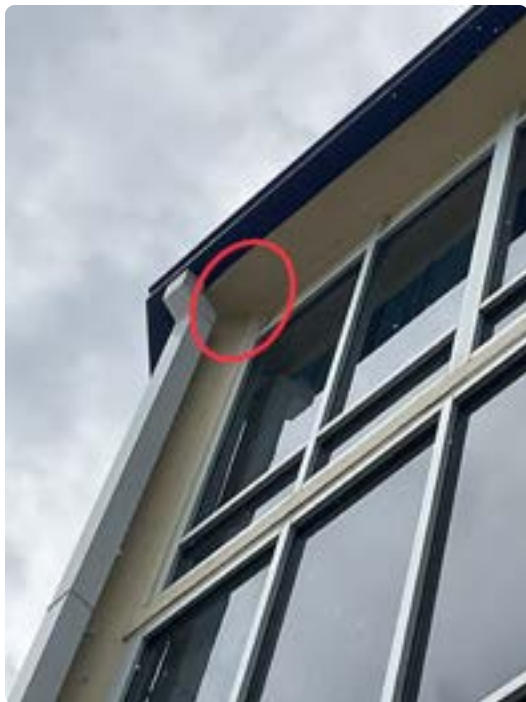
Concrete spalling in roof soffit on left side of middle of rear elevation

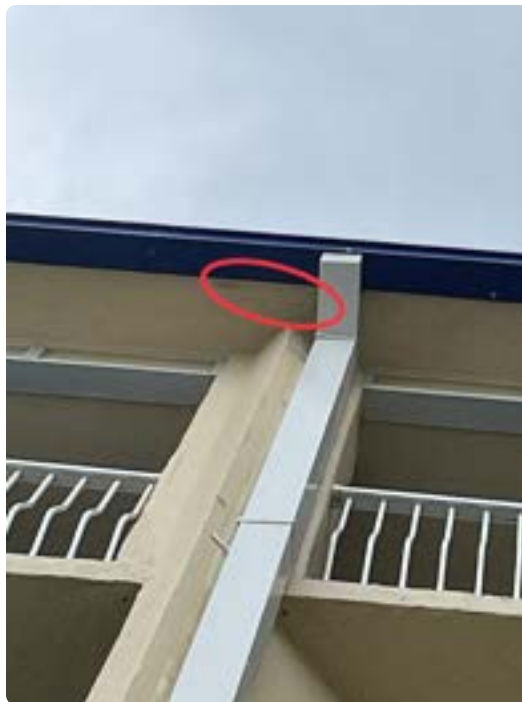
Concrete spalling on roof soffit above balcony near shed on rear elevation

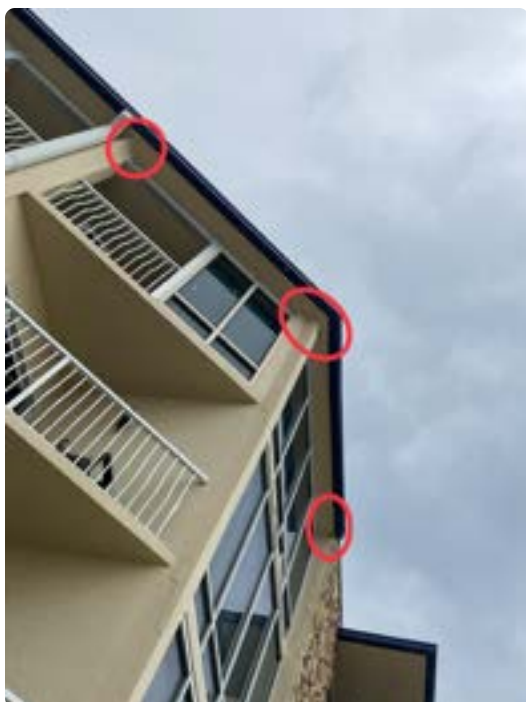
Multiple areas of concrete falling on roof soffit on right side of rear elevation

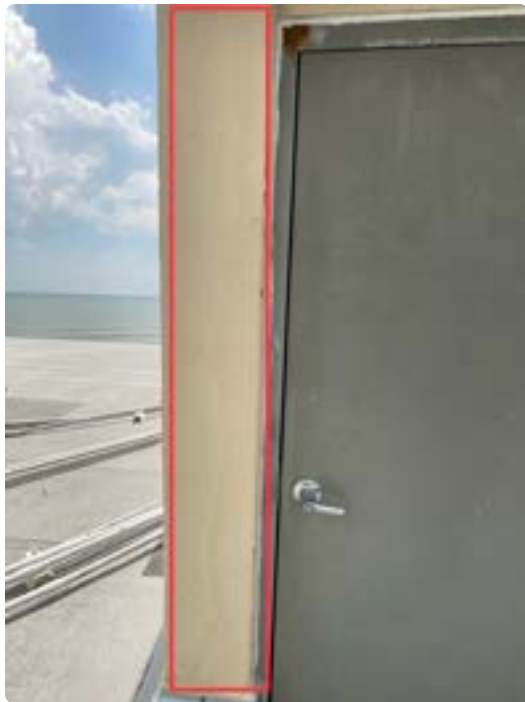
Concrete spalling on exterior wall around north side roof entry door

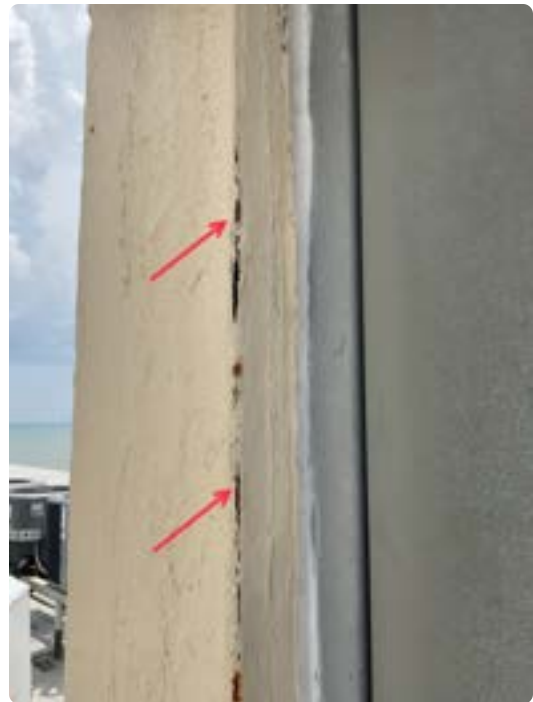
Cracks in stucco allowing for water intrusion into exterior wall near north side roof entry door

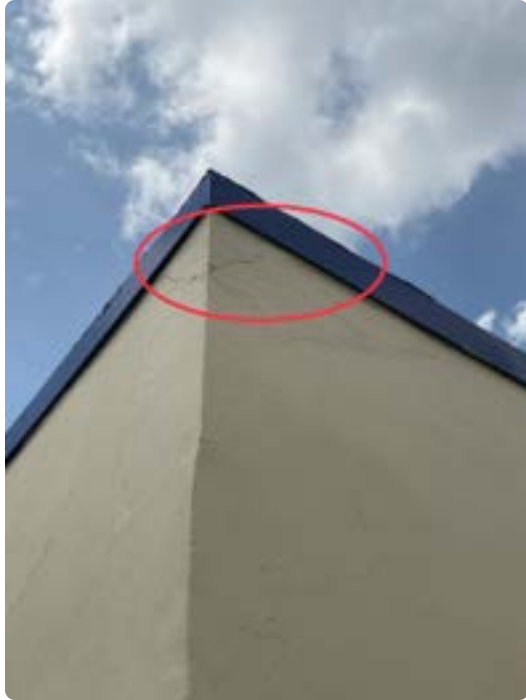
Concrete spalling at top of north side exterior stairwell wall on roof

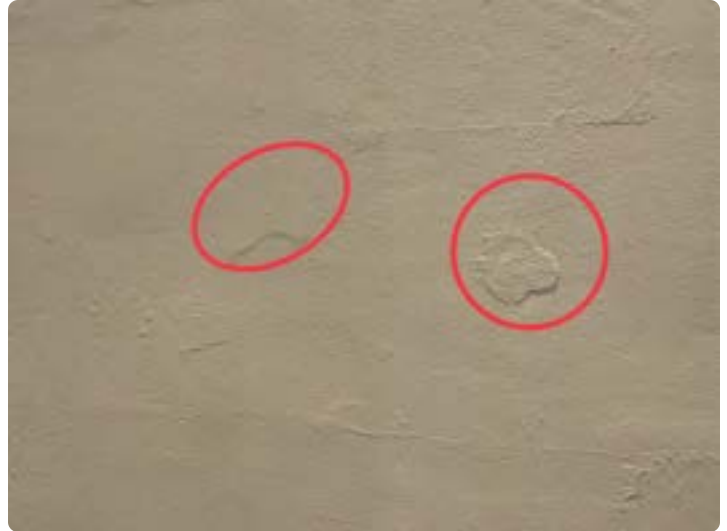
Small areas of concrete spalling on north side roof exterior stairwell wall

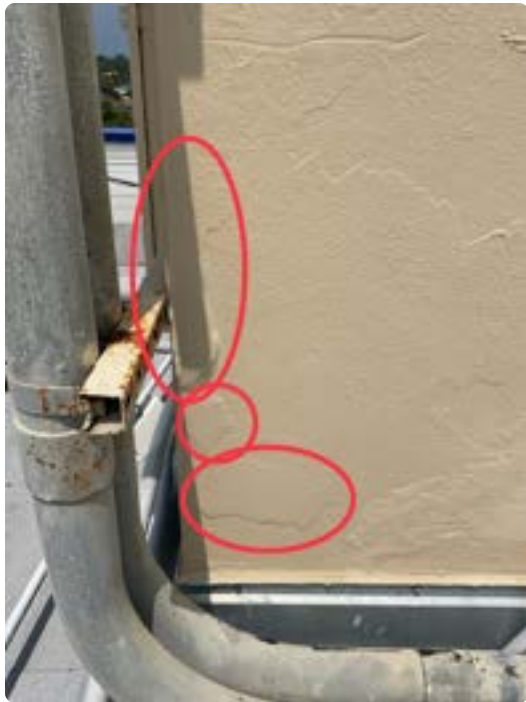
Concrete spalling on corner of southside exterior stairwell wall on roof

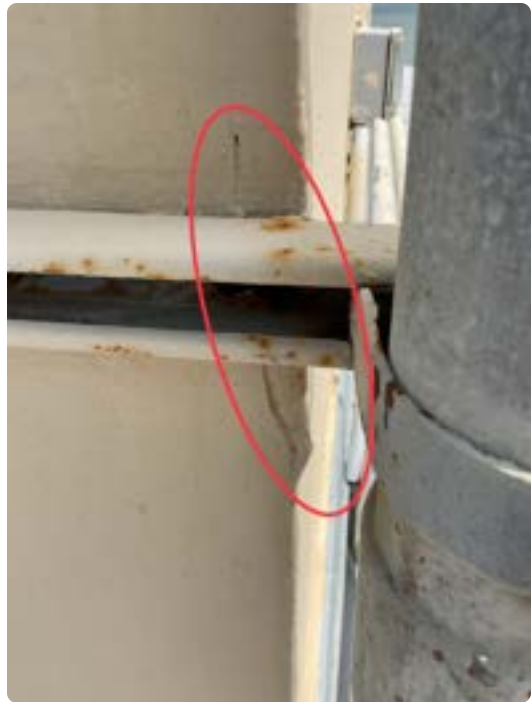
Side view of portion of concrete spalling on south exterior stairwell wall on roof

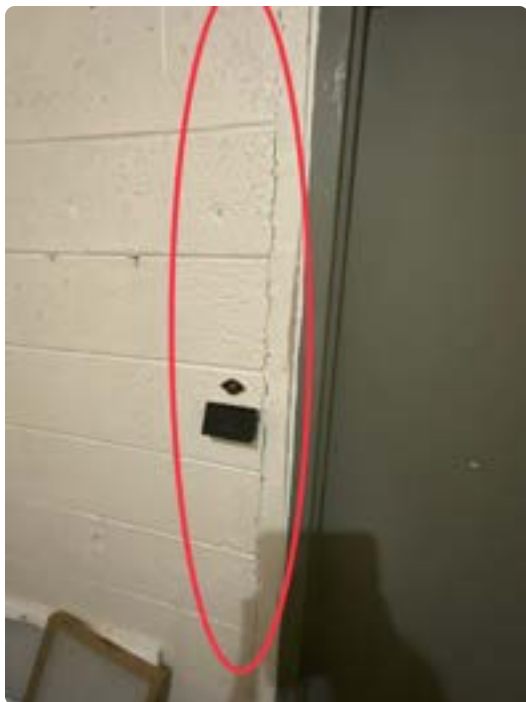
Cracked concrete to the left of roof entry door.

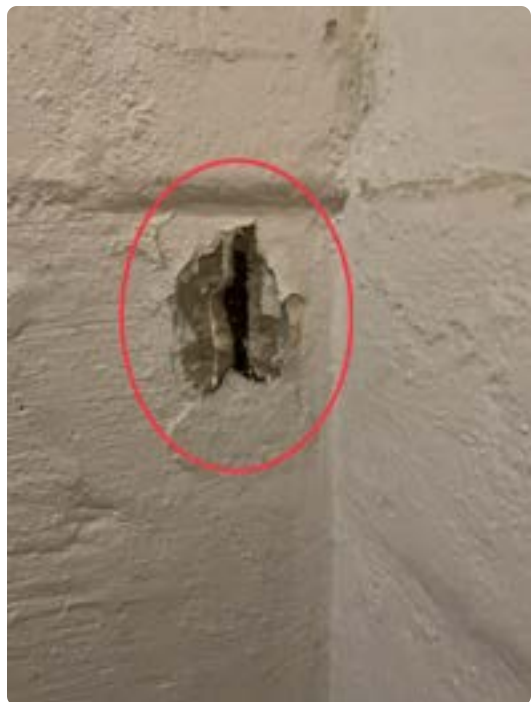
Concrete spalling with exposed corroded rebar on interior stairwell wall near Unit 4003

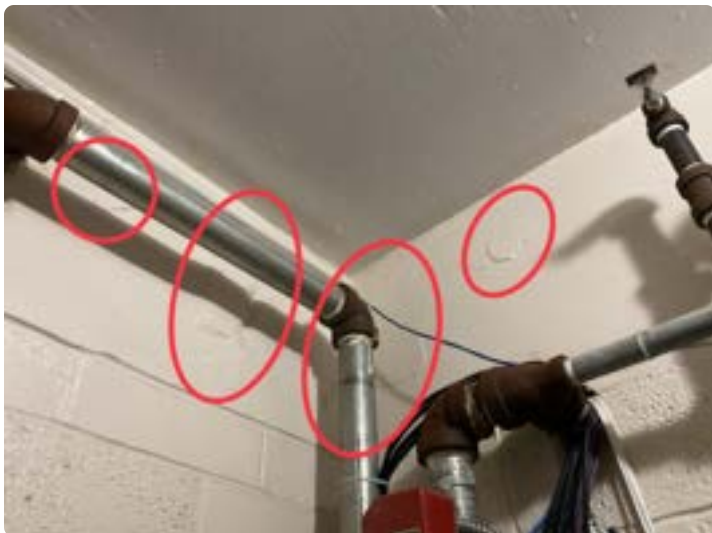
Possible concrete spalling on inside of stairwell near Unit 4003. Unclear if areas are spalling or a previous patch.

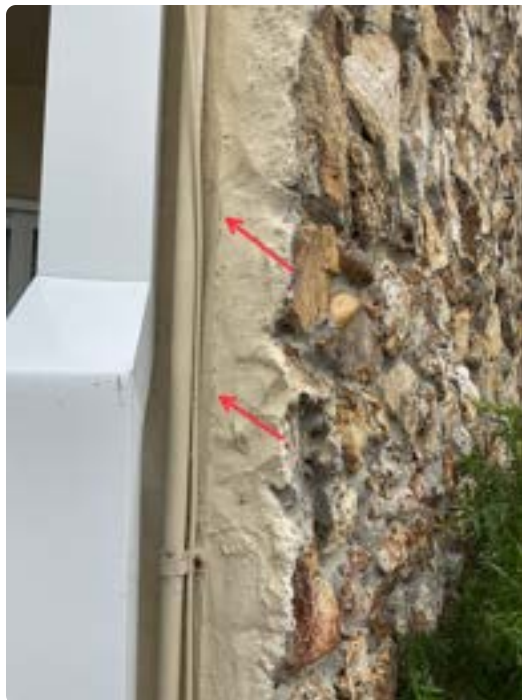
Cracks in sealant between exterior wall and stone cladding on left side of front elevation

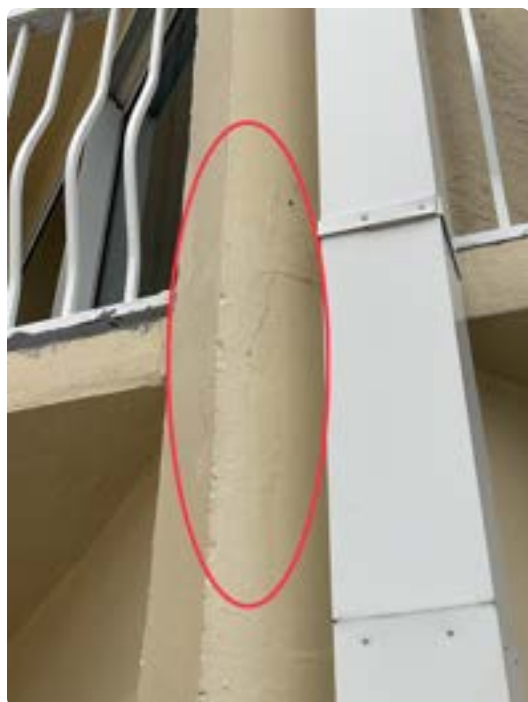
Possible concrete spalling on exterior wall near second balcony from right on the left side of the front elevation

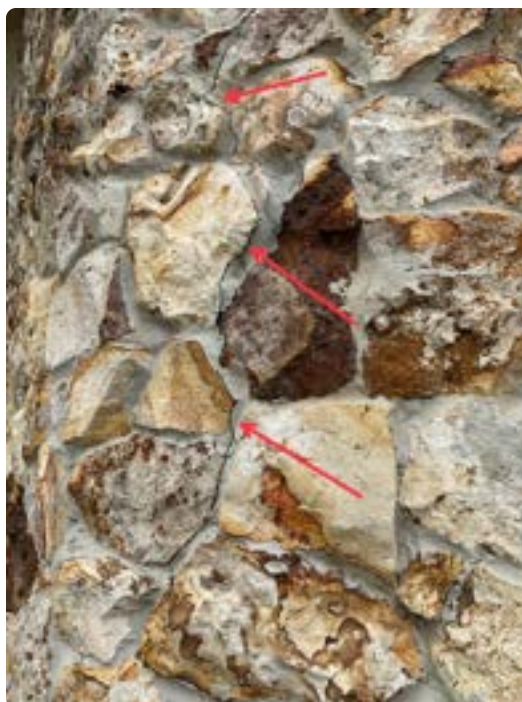
Cracks in grout around stone cladding on right side of front elevation

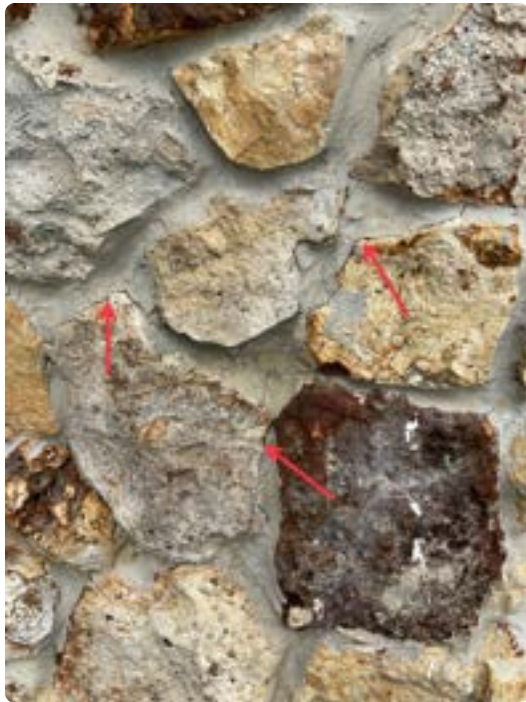
Cracks in grout around stone cladding on right side of front elevation

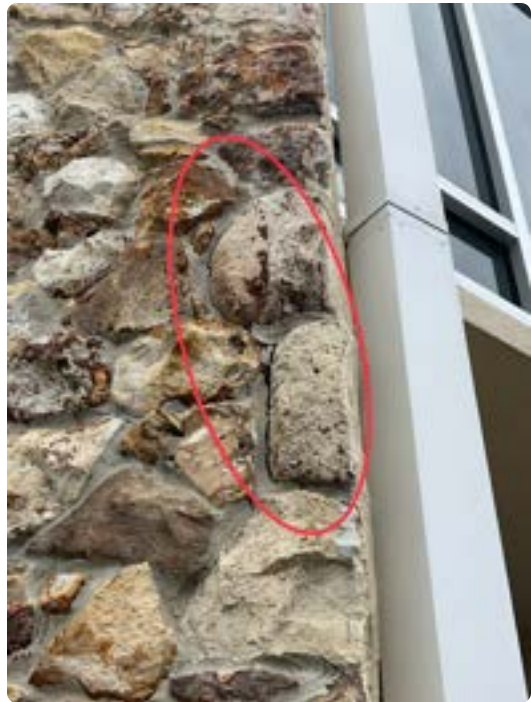
Cracks in grout around stone cladding on right side of front elevation

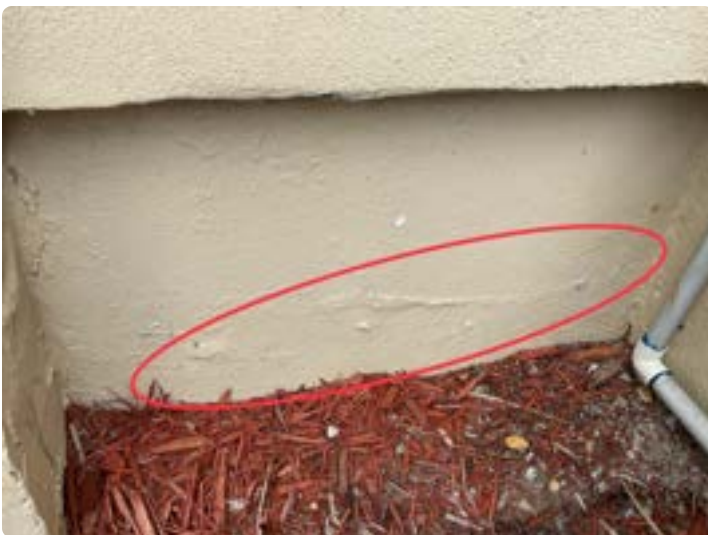
Concrete spalling at base of exterior wall near stone cladding near far-left balcony on the right side of the front elevation. Area is hollow when sounded.

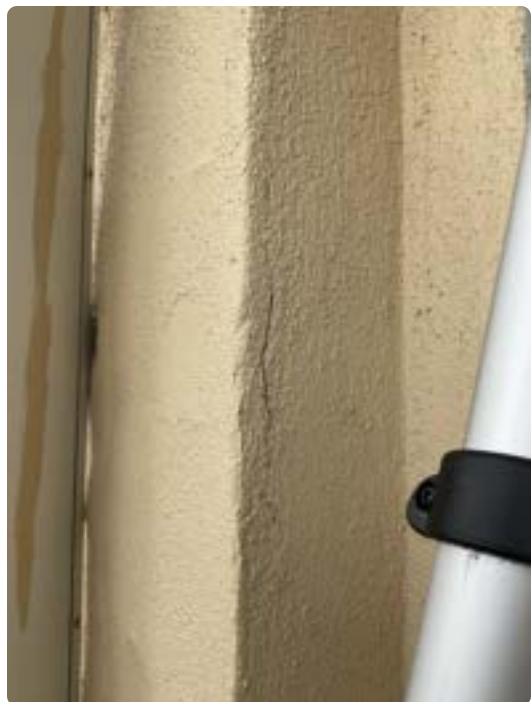
Concrete spalling on exterior wall behind stone cladding on right side of front elevation.

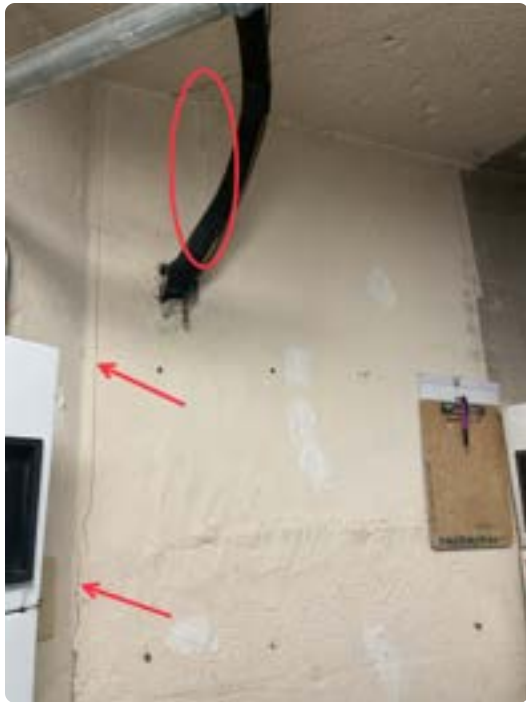
Cracking and spalling concrete on block wall in housekeeping laundry room. Entire area is hollow when sounded.

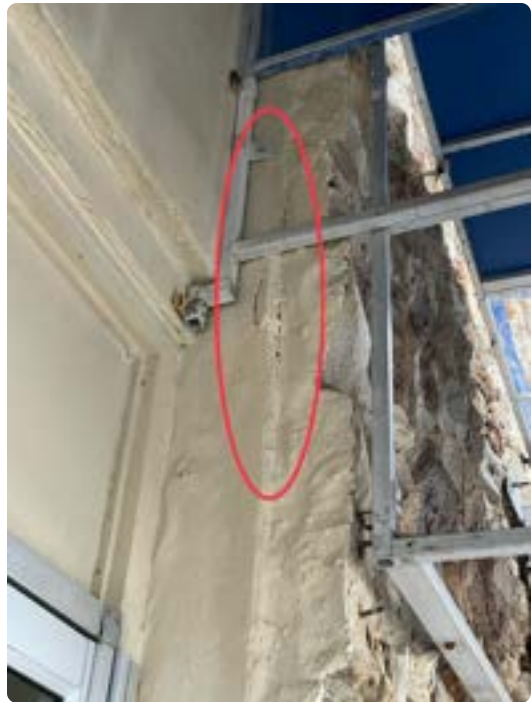
Concrete spalling on exterior wall behind stone facade on right elevation.

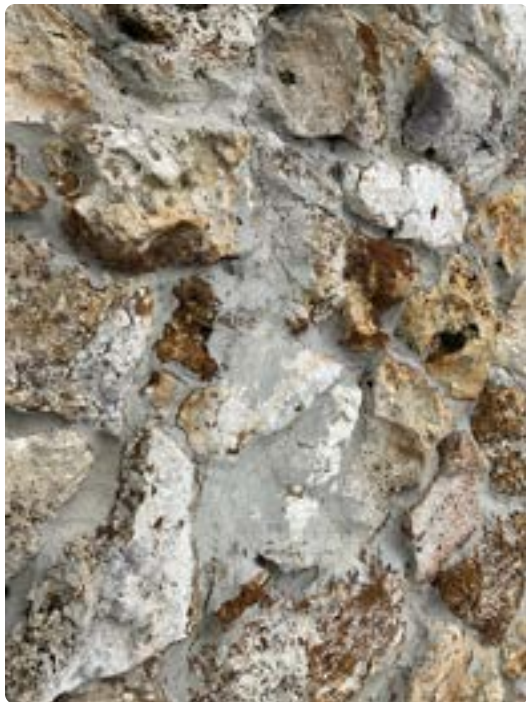
Cracks throughout grout on stone facade on left side of rear elevation

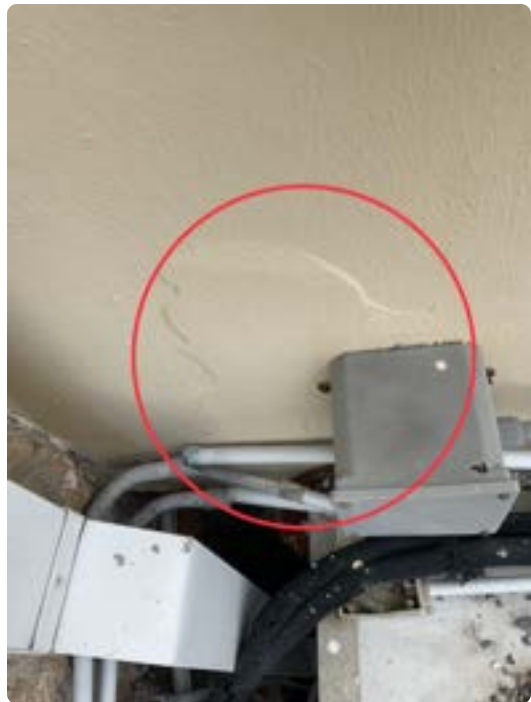
Concrete spalling on balcony wall on far-left side of rear elevation

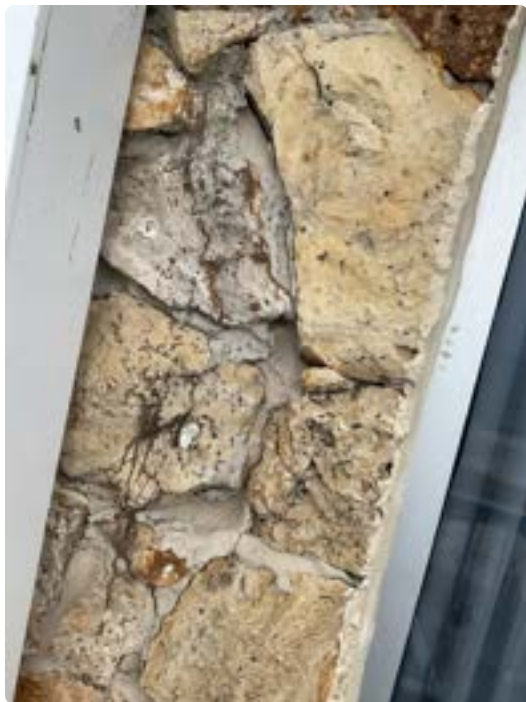
Cracks throughout stone facade grout on far-left side of rear elevation

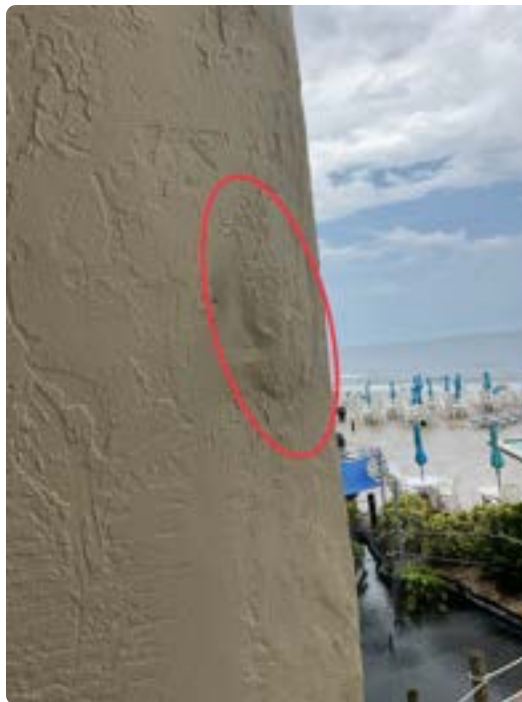
Hollow concrete behind paint bubbling on unit 2000 balcony demising wall

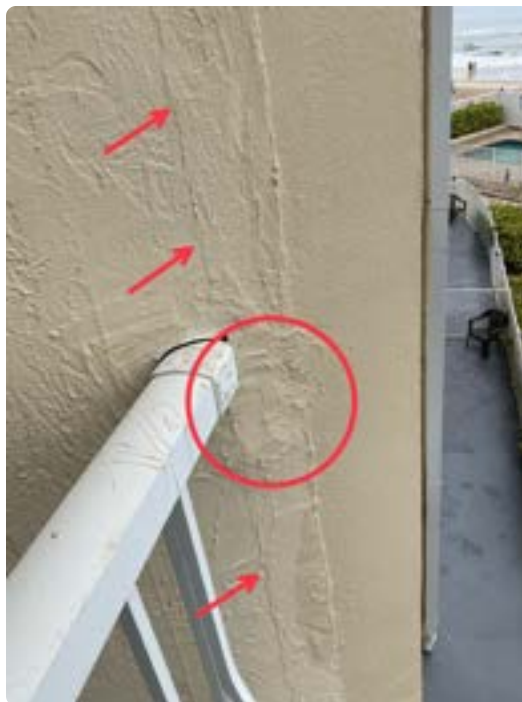
Crack in previous remediation on Unit 3004 balcony. Area is hollow where circled.

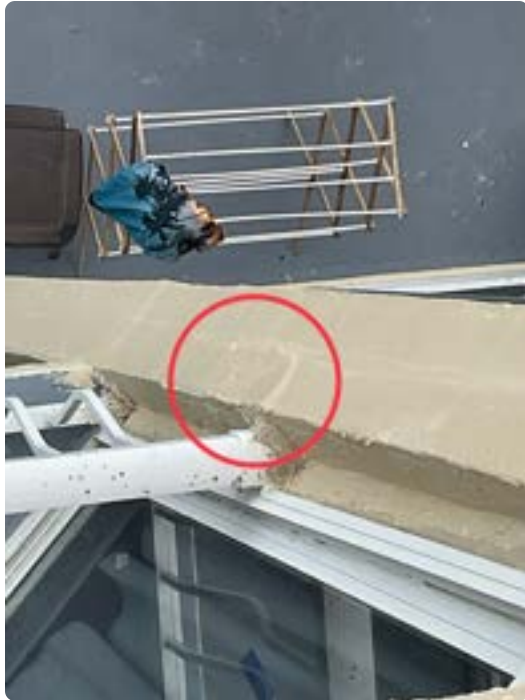
Concrete spalling near railing connection on Unit 2005 balcony

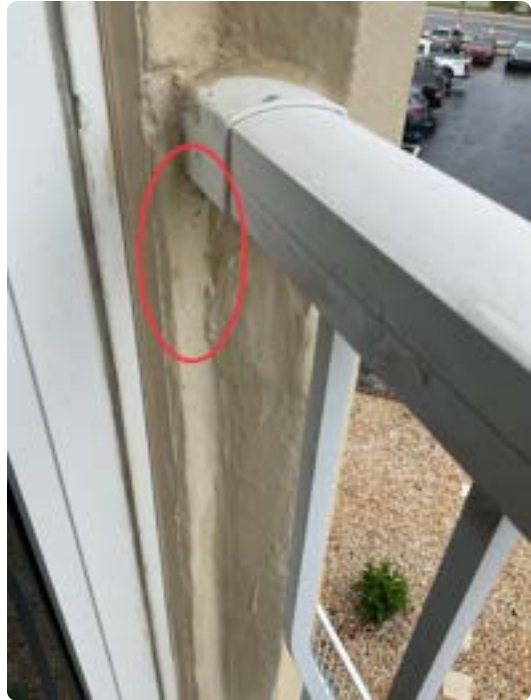
Small area of concrete spalling below railing connection on Unit 3014 balcony

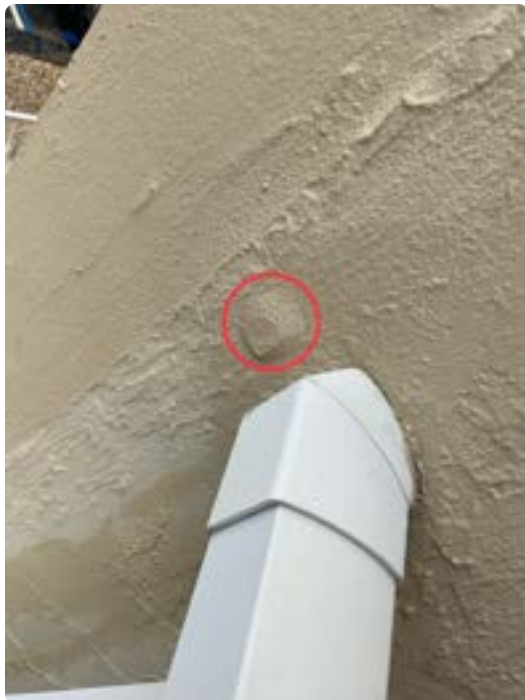
Small area of concrete spalling below railing connection on Unit 3014 balcony

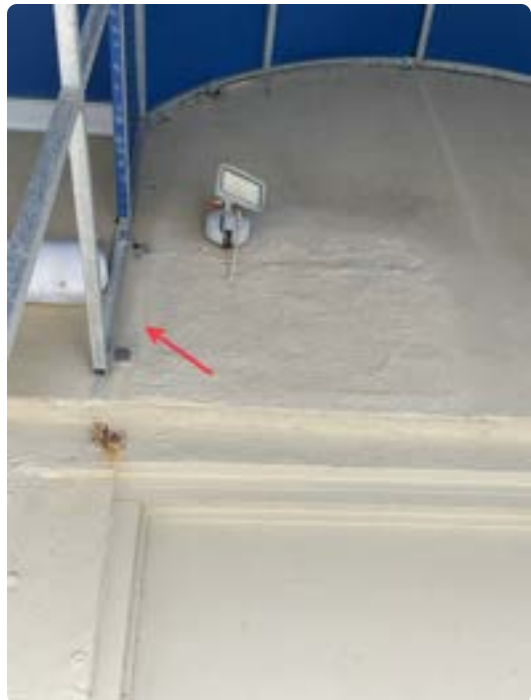
Crack around previous remediation on right elevation

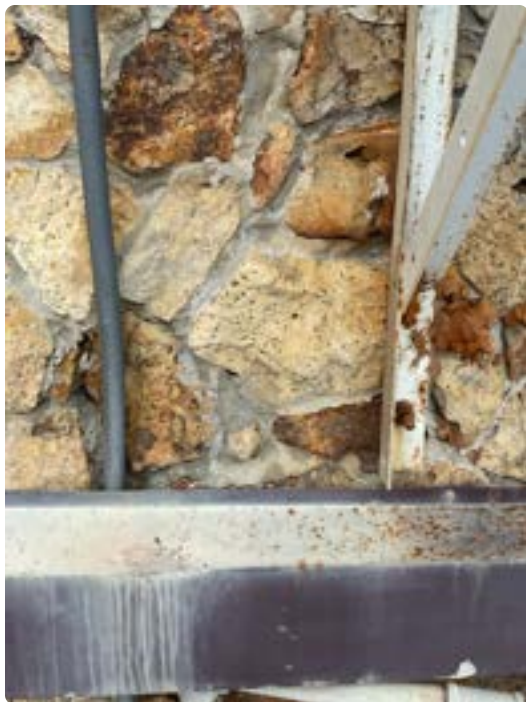
Cracks in stone facade and grout on right elevation

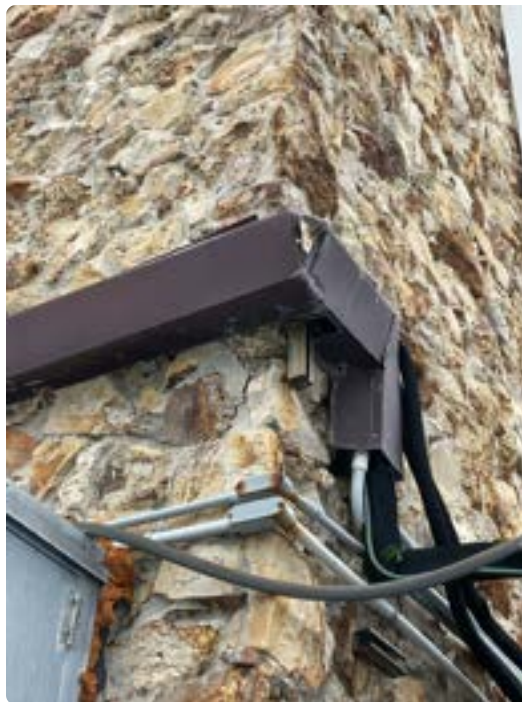
Large cracks in grout in stone facade on far-right side of right elevation

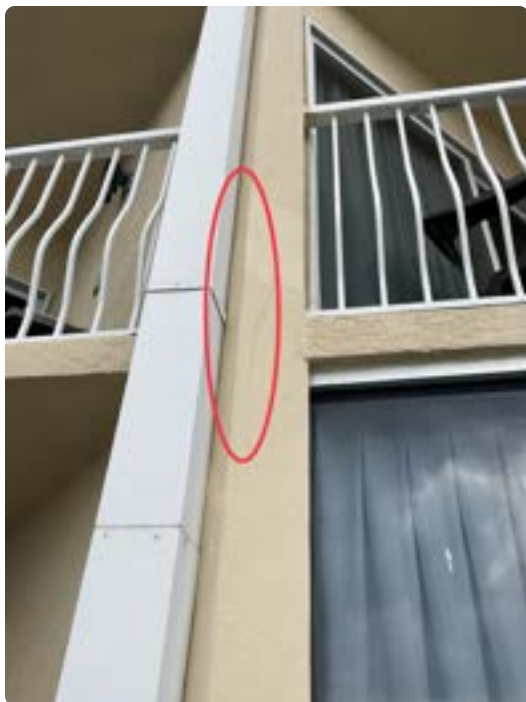
Concrete spalling on demising wall near 4th balcony from left from pool entry door

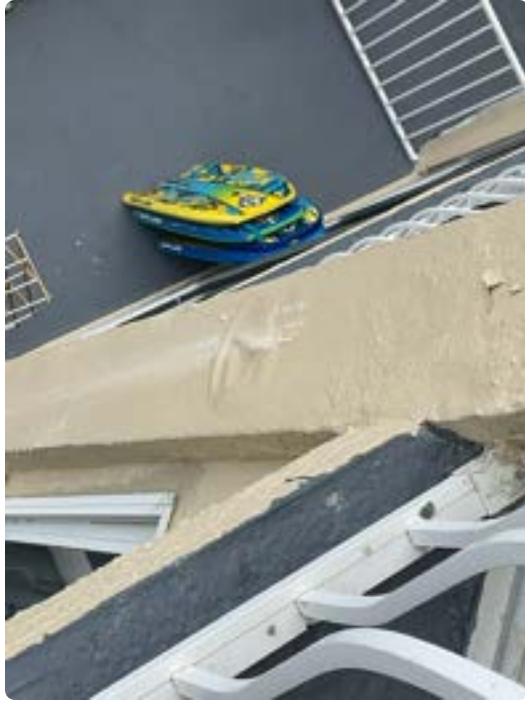
Coating bubbling on Unit 2005 balcony demising wall

Maintenance	Minimal amount of bubbles identified in coating. During next building painting cycle, all bubbles should be popped and the areas should be recoated.
Condition	Waterproofing in average condition for age.

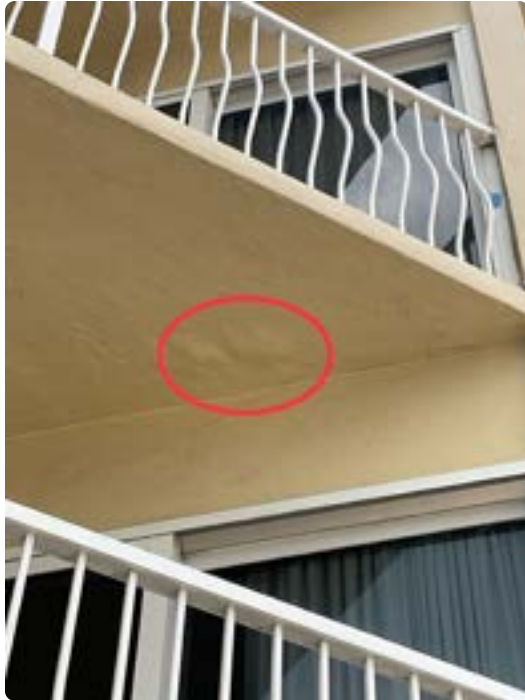
Bulges in balcony soffit on second balcony from left on the left side of the front elevation. Unclear from ground if area is due to concrete spalling, past remediation, or paint bubbling.

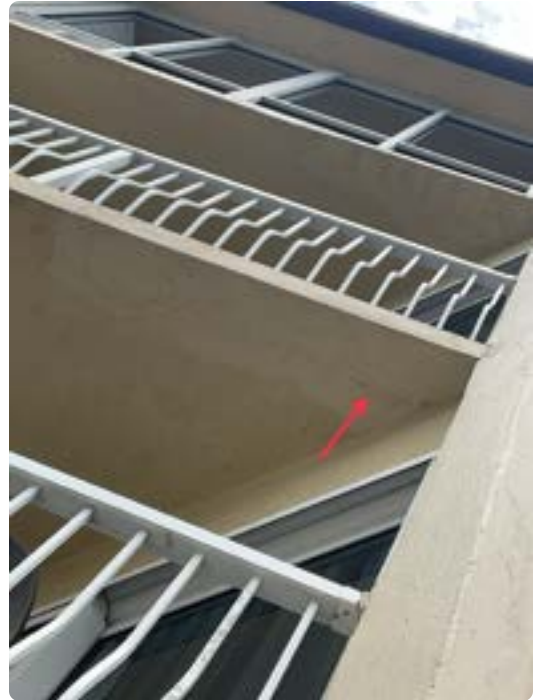
Cracks in area of previous remediation on second floor, second balcony from right on the left side of the front elevation

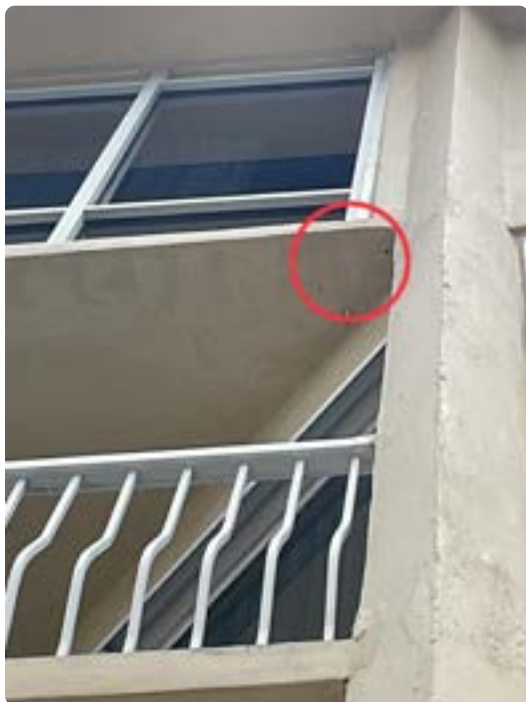
Cracks in area of previous remediation on third floor, second balcony from right on the left side of the front elevation

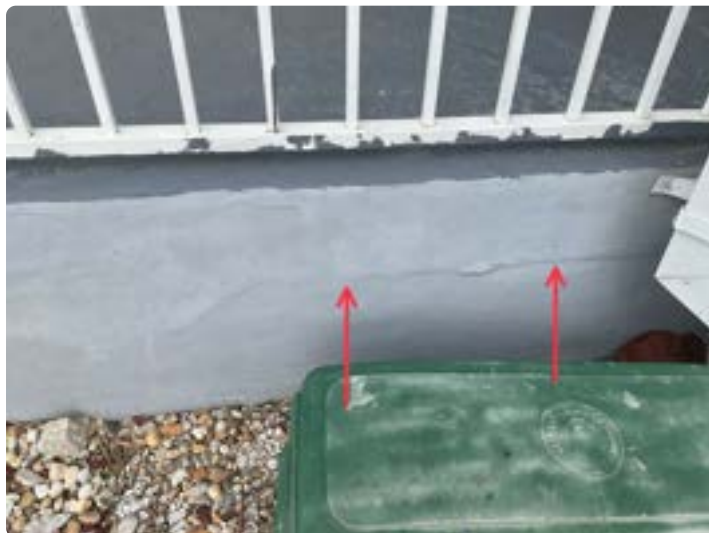
Crack in patio wall and small area of concrete spalling on far-right patio on right side of front elevation

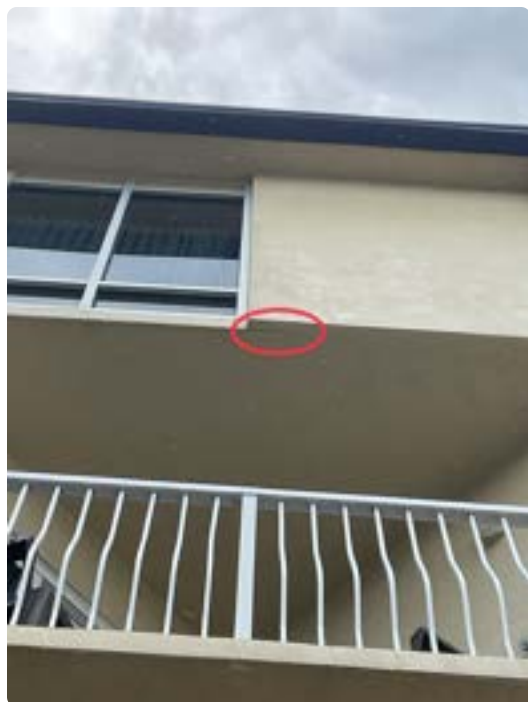
Crack in far-left balcony soffit on right side of right elevation

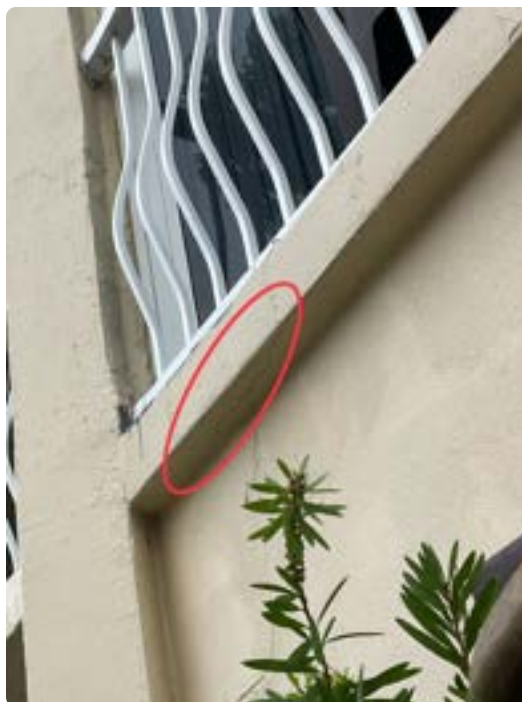
Crack below balcony slab on second floor, far-left balcony on right side of front elevation

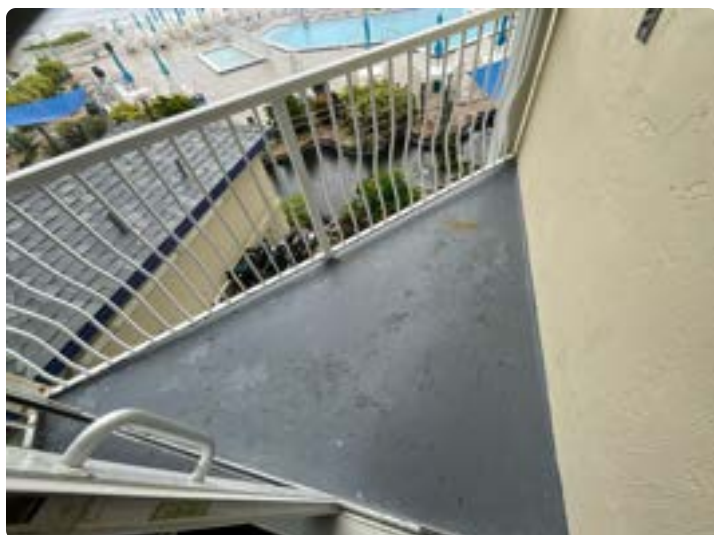
Delaminated coating on Unit 2029 balcony

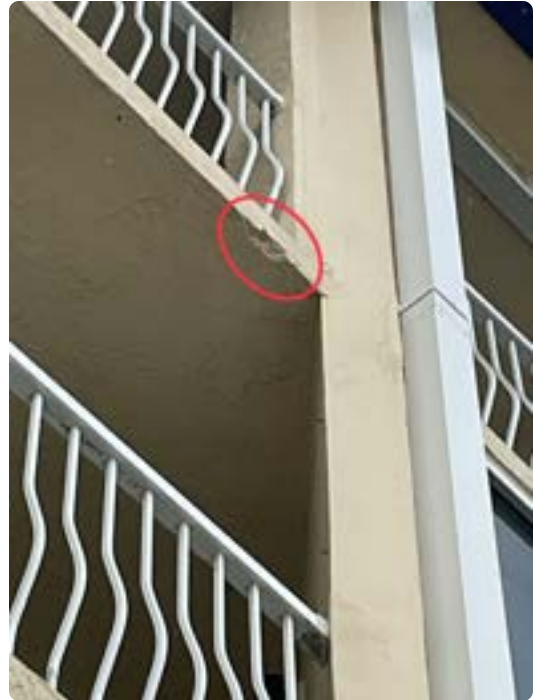
Concrete spalling on balcony slab near middle of rear elevation

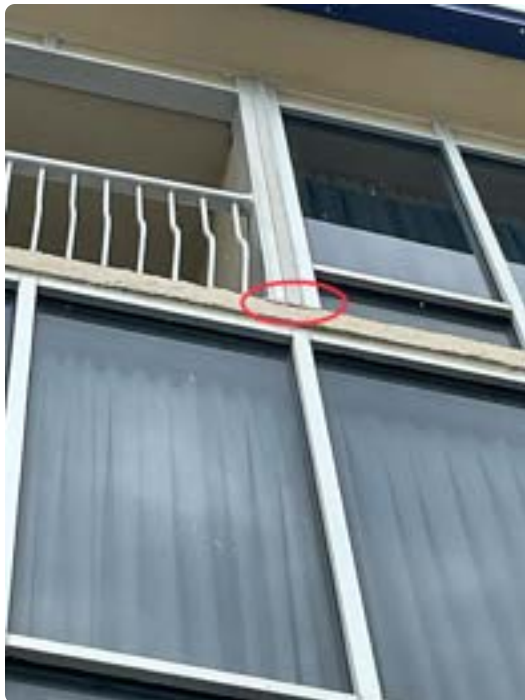
Concrete spalling at base of demising wall on balcony near blue tarp on rear elevation
