**Milestone Phase I Report
Ocean East Resort Club Association, Inc.**

Report Date: 9/24/2024

Inspection Date: 8/8/2024

867 S Atlantic Ave, Ormond Beach, FL 32176, USA

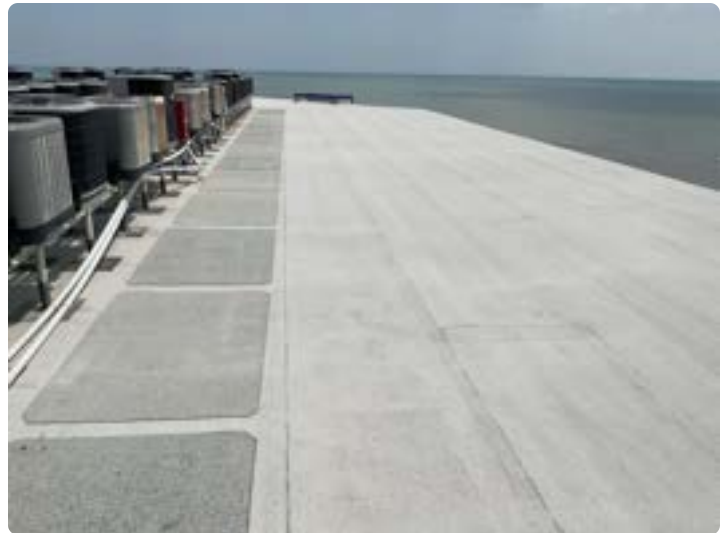
Small area of water ponding on roof

Deficiencies	No deficiencies observed.
Maintenance	<ul style="list-style-type: none">Some small areas of water ponding identified on roof. Association should monitor water ponding to ensure it does not stay on roof for longer than 72 hours.Multiple areas of concrete spalling identified on roof soffit on multiple elevations. Areas of concrete spalling should be repaired during the building's next painting/concrete restoration cycle.
Condition	Roof replaced in 2022 due to hurricane damage. Roof in expected condition for age.

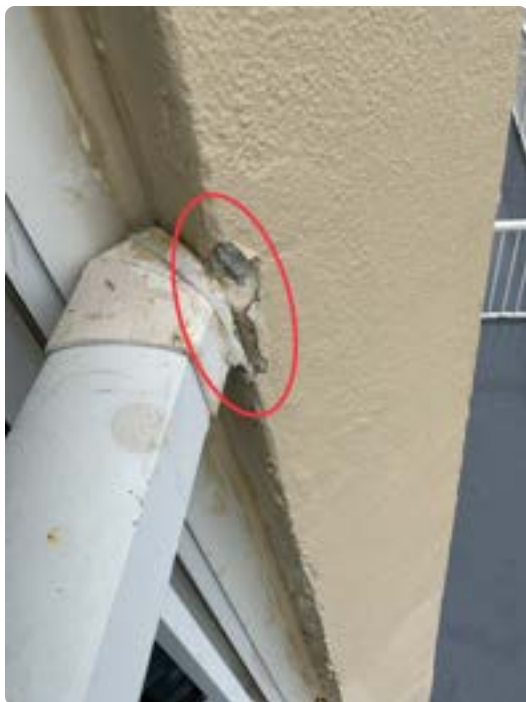
Chip in exterior wall near railing connection on Unit 2016 balcony. Area should be sealed to prevent water intrusion

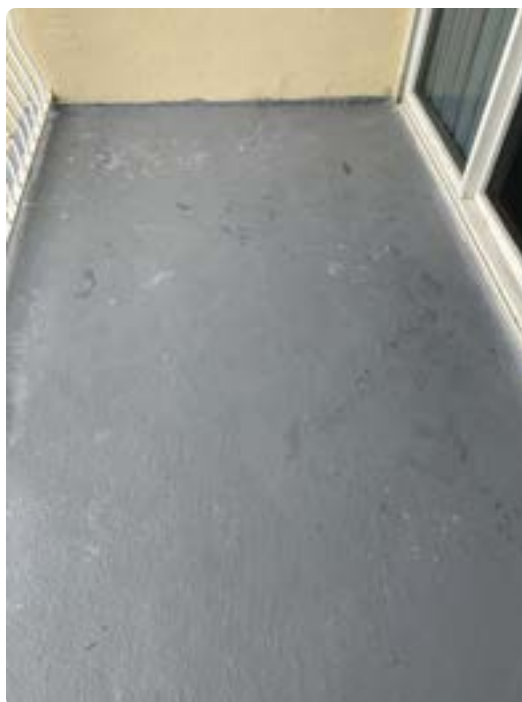
Delaminated coating on Unit 2000 balcony

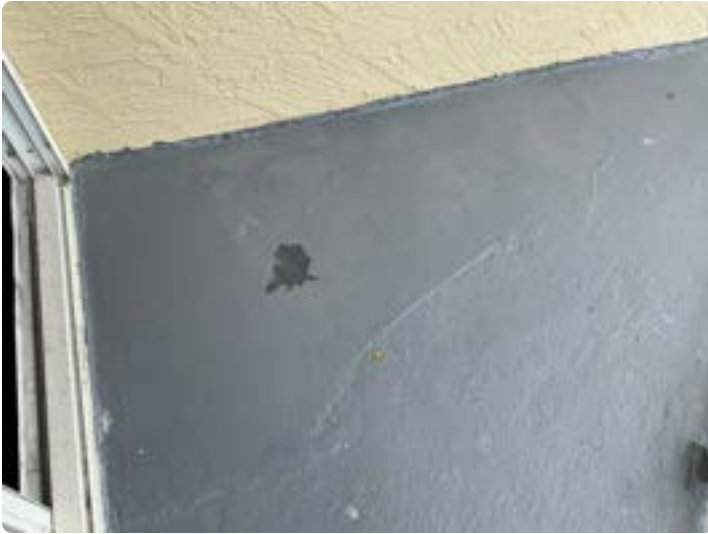
Apparent previous remediation on Unit 2004 balcony slab. Area is not hollow when knocked on.
